HVS-NORDIC

The activity of the second period in Finland 2000 - 2003

Finnra Reports 45/2003

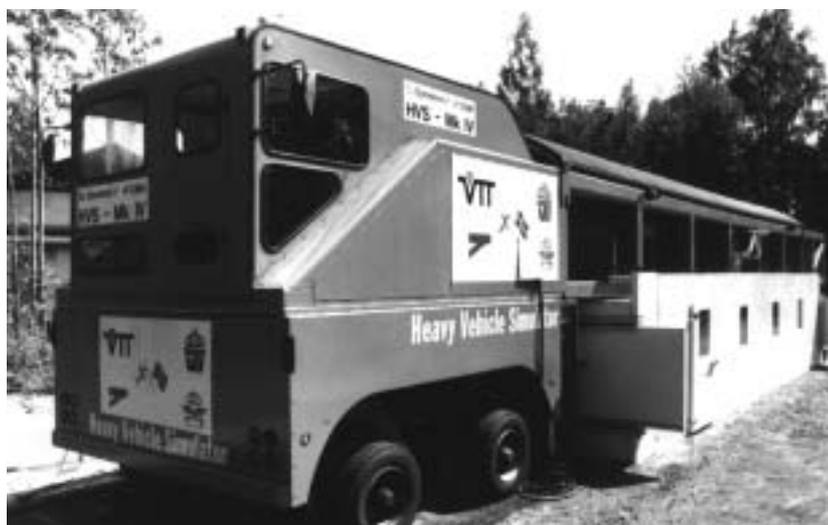
The machine is called HVS-NORDIC. The HVS Mark IV is a mobile full-scale accelerated pavement testing facility (Figure 1.1), whose loading is linear. It can be run over a short distance independently at walking speed, though in practice only at a specific test site. It can be moved as a semi-trailer over longer distances.

Figure 1.1. HVS-NORDIC accelerated pavement testing facility.

The HVS-NORDIC has a heating/cooling system and, thus, the temperature can be kept constant. The air temperature inside the heating/cooling box is controlled in order to keep the pavement temperature constant. The selected standard temperature of the bituminous layers was +10°C.

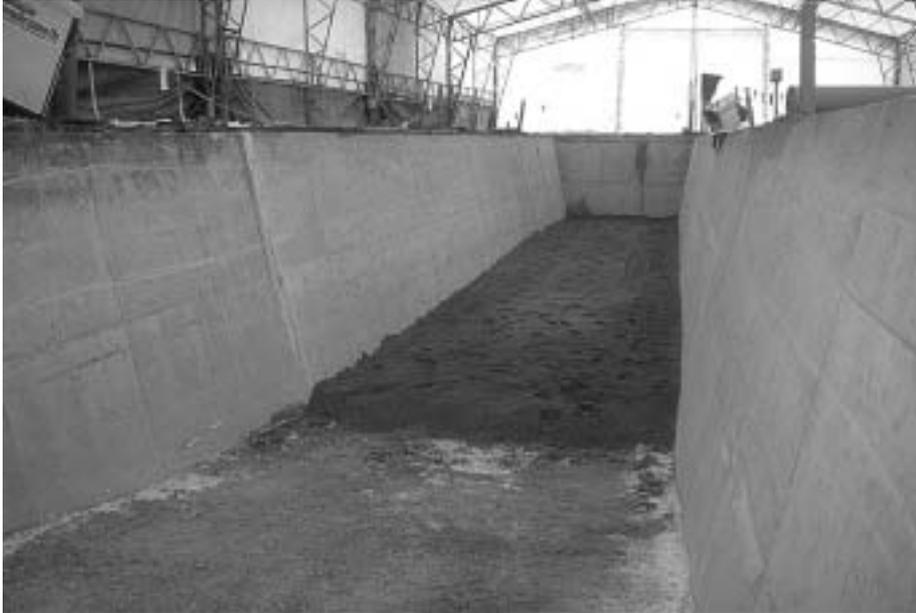
The test site is located a few hundred metres from the VTT office. The site includes two test basins. One test basin is made of concrete; the walls have thermal insulation and there is complete water table regulation (Fig 1.2). Its length is 36 m including a 16-m-long slope and its depth is 2.5 m and width 4 m at the top and 3 m at the bottom. Two or three test pavements can be constructed in the test basin.

Figure 1.2. Concrete basin in Otaniemi.
